Historic Lighthouse Preservation Handbook

1997

Introduction

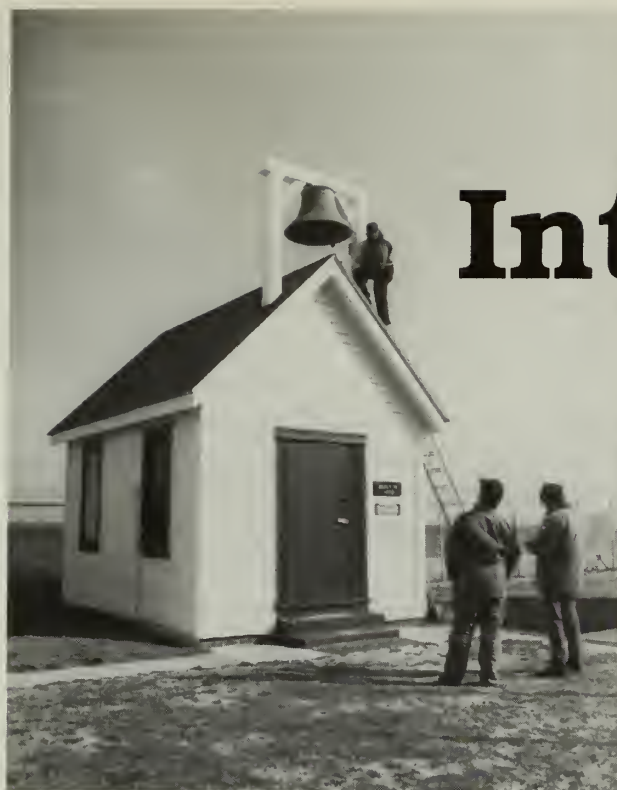
Figure 1. Conducting a condition assessment at Cove Point Light Station, near Lusby, Maryland, in 1995.

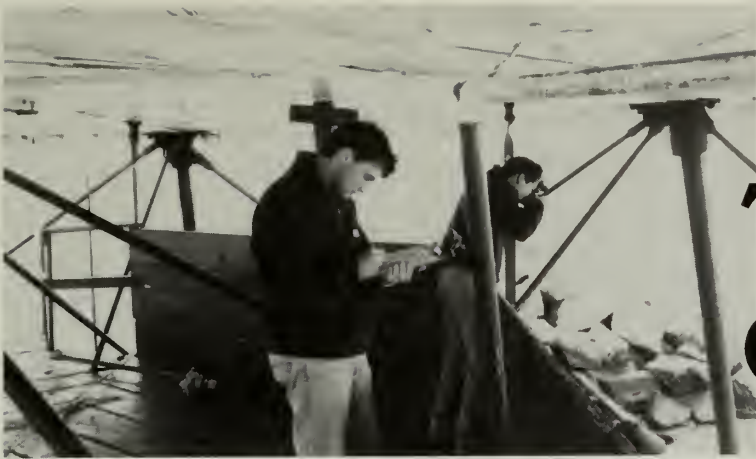
Figure 1. Mike Seibert and Paul Neidinger of Williamsport Preservation Training Center perform a condition assessment of Thomas Point Shoals Light Station, Maryland, in 1995.

- Thomas Point Shoals Light Station, Maryland, built in 1875, is the last largely unaltered spider-foundation cottage-type screwpile lighthouse in the United States. As such, it is significant for American architecture and engineering.

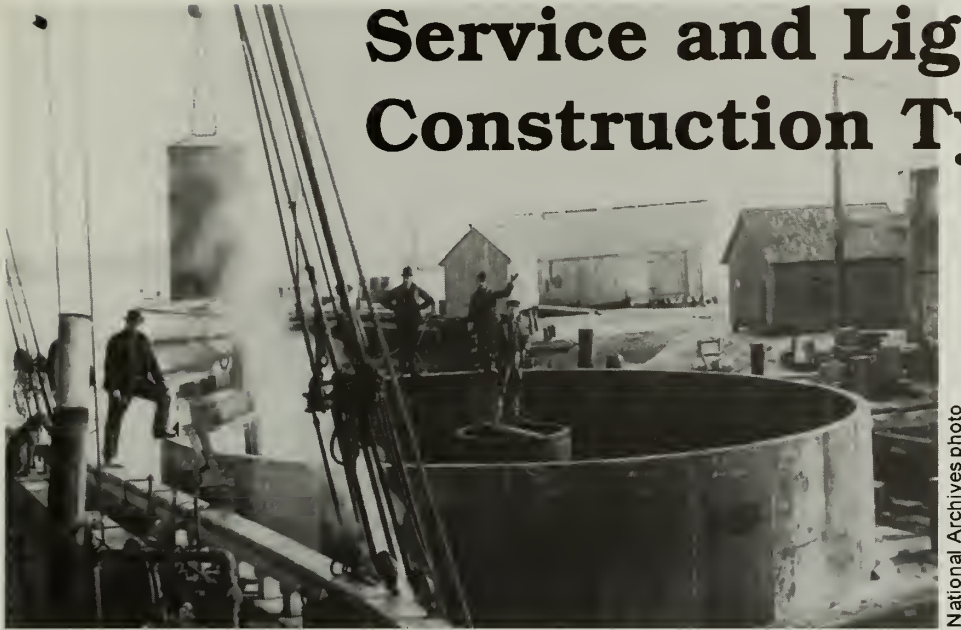
Figure 1. Assembly of Point No Point Lighthouse caisson at Solomons, Maryland, before being transported to site in Chesapeake Bay.

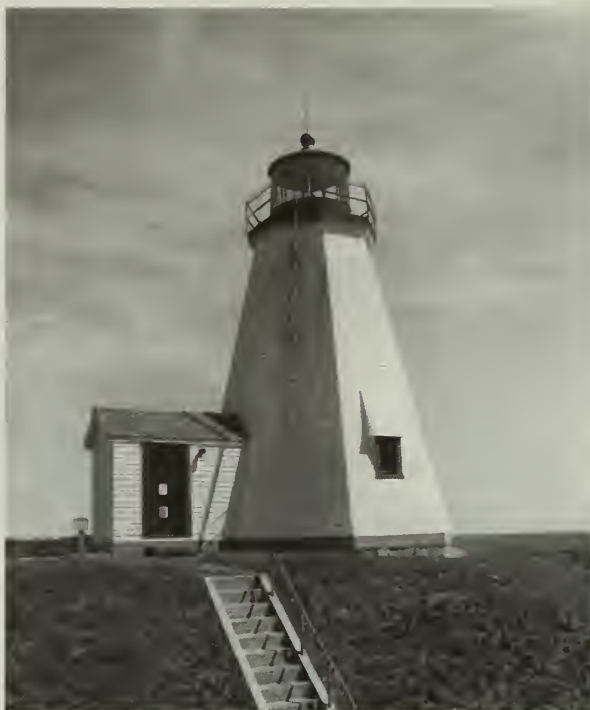
Figure 3. Gurnet Point Lighthouse, wooden tower near Plymouth, Massachusetts.

Wooden tower: Most early wooden towers have burned and/or been replaced. Prospect Harbor Lighthouse (1891), Maine, is a good example of a stand-alone, conical wooden light tower. Plymouth/Gurnet Point Light (1843),

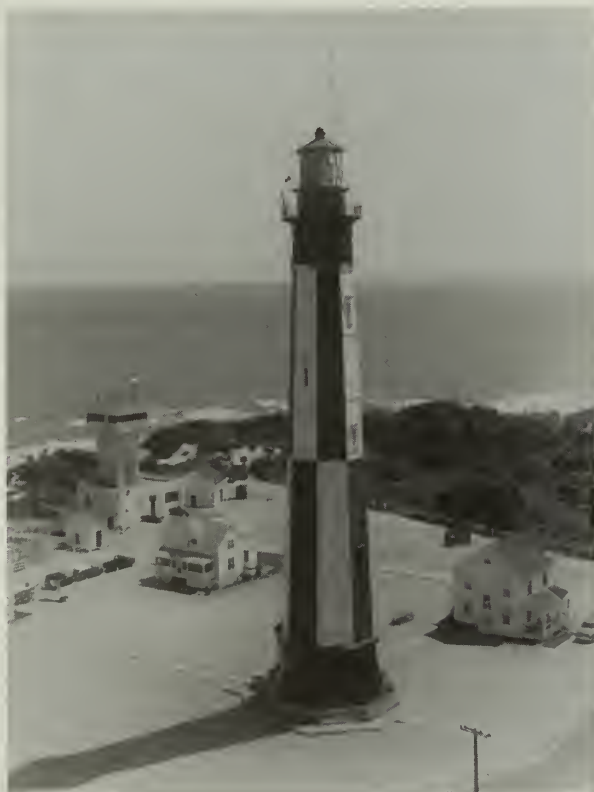
Figure 4. Cape Henry Light Station, cast-iron tower, Fort Story, Virginia.

Cast-iron-plate tower: Cast iron was lighter than stone or brick, relatively inexpensive, strong, watertight, and had a slow rate of deterioration. The second Cape Henry Lighthouse (1881), Virginia, is the tallest cast-iron-plate tower in the United States at 163 feet. Steel and wrought-iron plate was also sometimes used. This construction type was capable of being dismantled and moved; examples include Cape Canaveral, Florida and Hunting Island, South Carolina.

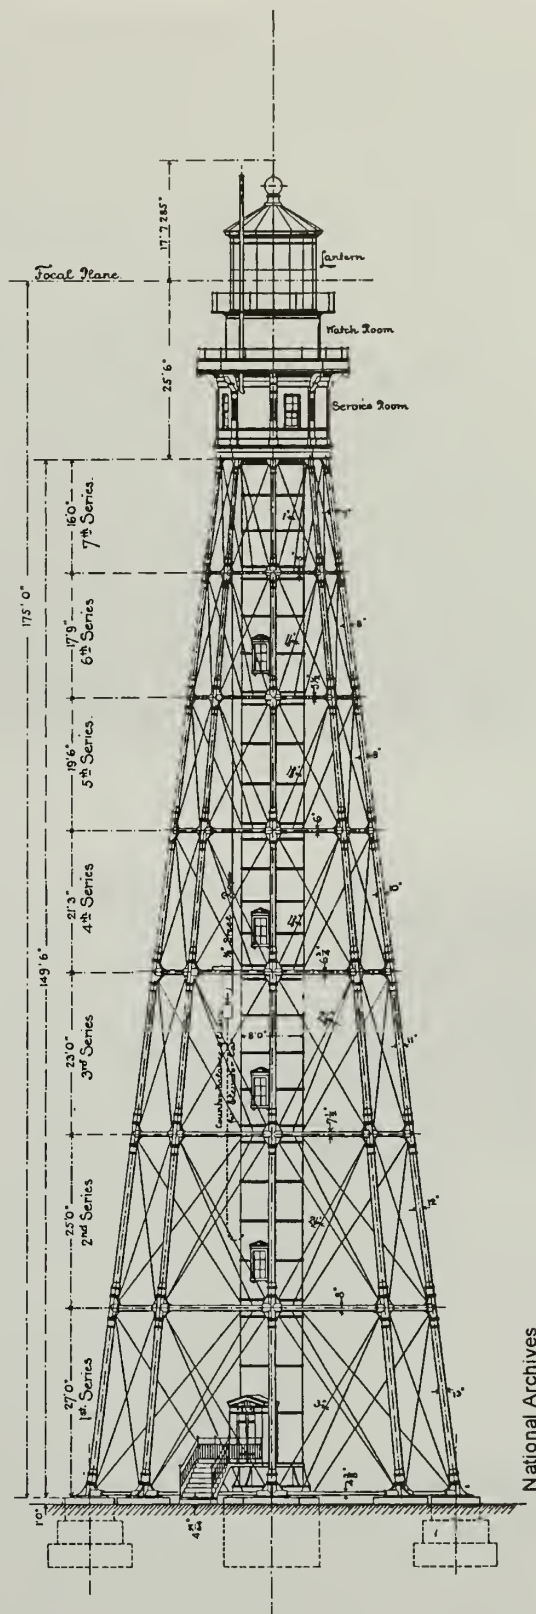
Figure 5. Construction drawing for Cape Charles Lighthouse, Virginia, an onshore skeletal tower.

Skeletal tower: Onshore skeletal towers were built of metal and were typically constructed on concrete foundations. Offshore skeletal towers were also built of metal and typically constructed with straight or screwpile foundations (discussed below). Manitou Island Lighthouse (1861) and Whitefish Point Lighthouse (1861), Michigan, both built from the same plan, are the earliest onshore skeletal towers built in the United States. Like the cast-iron-plate tower, skeletal towers could also be dismantled and moved.

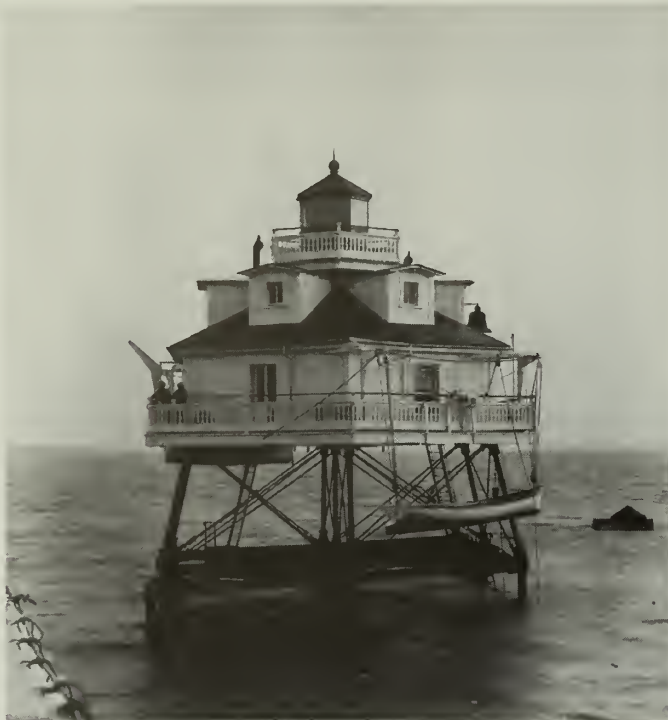
Figure 6. Thomas Point Shoals Lighthouse with screwpile foundation located in Maryland's Chesapeake Bay; shown here in 1885.

Screwpile: To increase the holding power of the pile, a screw-like flange was fastened to the bottom of the pile and wound like a screw into the substrate. There are two principal screwpile type lighthouses, 1) low spider-like foundations for rivers, bays, and sounds, and 2) tall offshore coastal towers. Perhaps as many as 100 spider-like screwpile lighthouses were built throughout the Carolina sounds, the Chesapeake Bay, Delaware Bay, along the Gulf of Mexico, and one even at Maumee Bay (1855) on Lake Erie in Ohio. Thomas Point Shoals Lighthouse (1875), Maryland, is the oldest extant, unmoved, spider-like screwpile lighthouse in the United States. The first of the tall skeletal screwpile coastal towers built in the United States was Carysfort Reef Lighthouse (1852), Florida, which still stands. A few offshore screwpile skeletal tower lighthouses built on coral reefs used foot plates or disks to help disperse the weight of the tower. Examples in the Florida Keys include Carysfort Reef Lighthouse (1852), Fowey Rocks Lighthouse (1878), and American Shoal Lighthouse (1880).

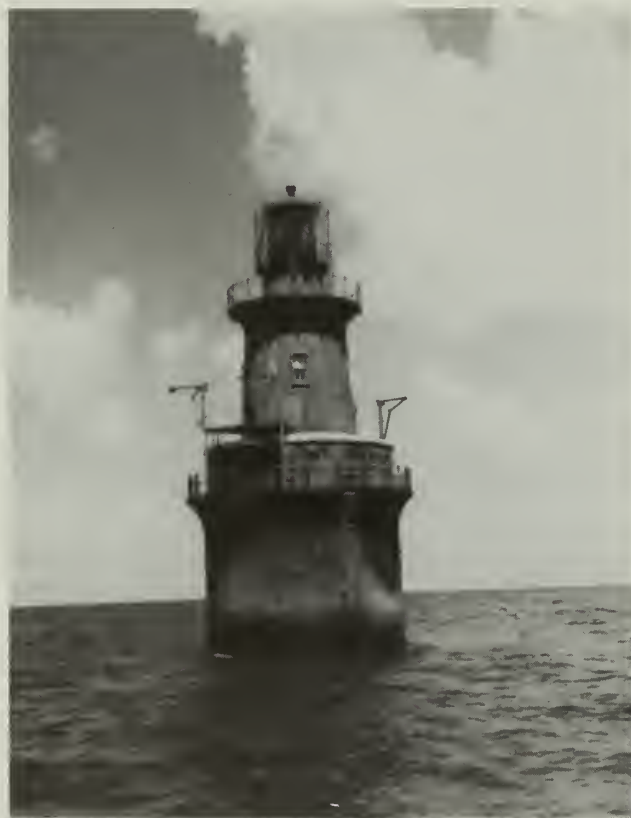
Figure 7. Sabine Bank Lighthouse with caisson foundation in Texas.

Caisson: Caisson foundations were best suited for unconsolidated bottoms composed of sand or mud. The caisson lighthouse type used a large cast-iron cylinder, which was sunk on the bottom and filled with rock and concrete to form a foundation. The caisson foundation was sturdier and better able

to withstand heavy stress than the pile foundation lighthouses, so it is not surprising that caisson lighthouses were built in areas where moving ice was a hazard. The Craighill Channel Lower Front Range Lighthouse (1873), Maryland, is an early surviving example. Where bottoms were harder, contained rocks, and/or needed greater depth of penetration into the substrate, the pneumatic process was used. The substrate within the caisson was removed and the caisson allowed to sink further into the bottom. Eleven pneumatic caisson lighthouses were built in the United States. The Sabine Bank Lighthouse (1905), Texas, is the most exposed, located 15 miles offshore in the Gulf of Mexico—the only successful caisson south of the Chesapeake Bay.⁶

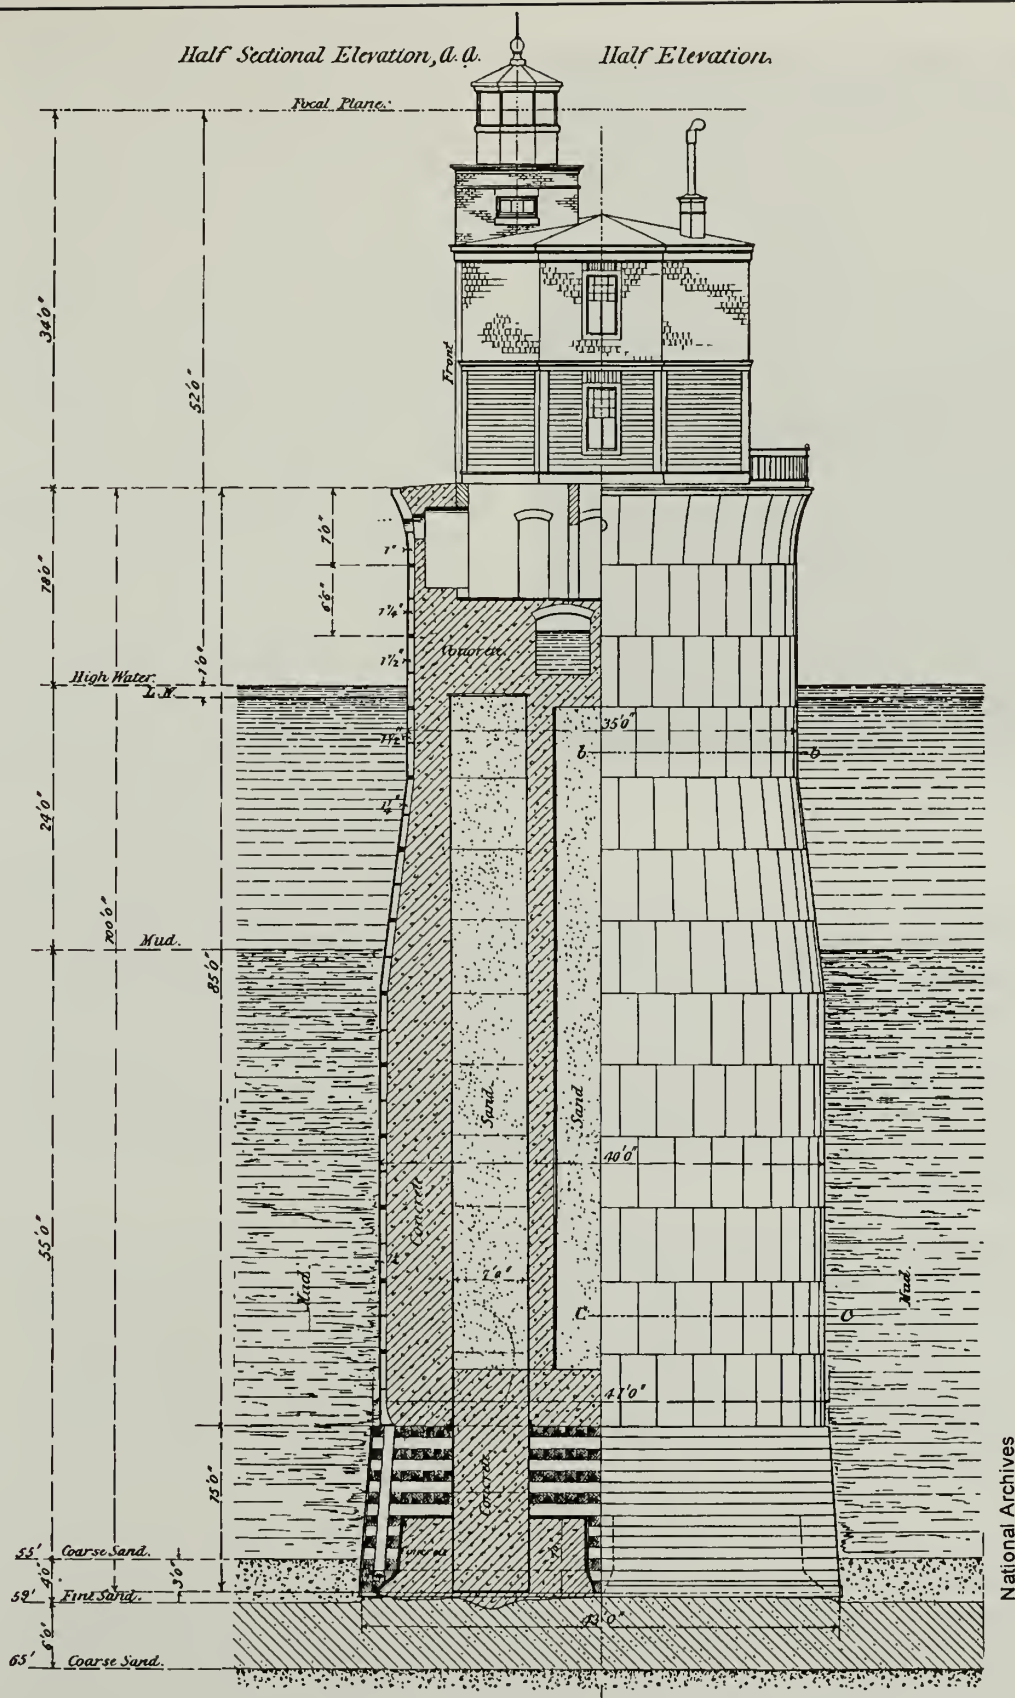
Figure 8. Construction drawing detailing the caisson foundation for Baltimore Lighthouse in Maryland's Chesapeake Bay.

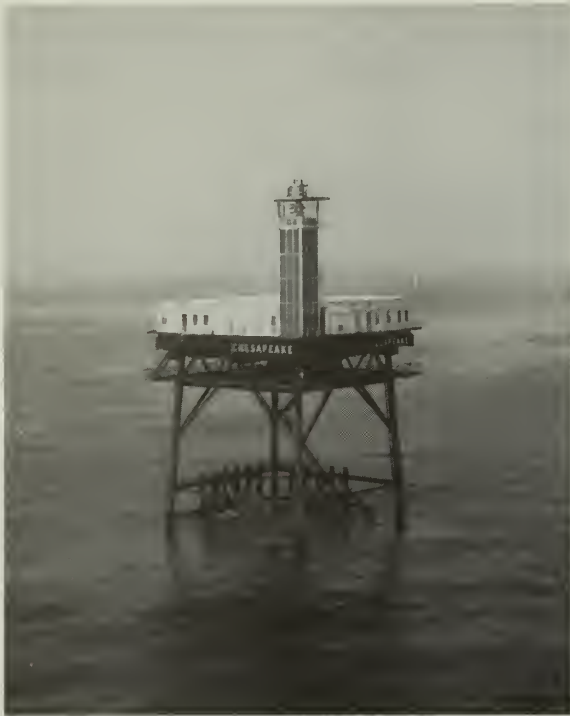
Figure 9. Chesapeake Light Station, Texas tower at entrance to Chesapeake Bay.

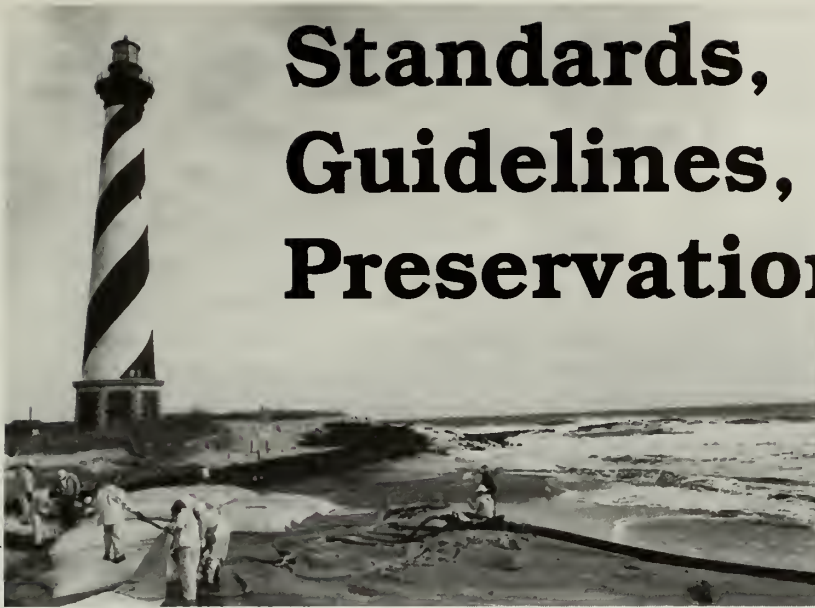
Figure 1. Sandbags are used to protect Cape Hatteras Lighthouse, Buxton, North Carolina, from further shoreline erosion.

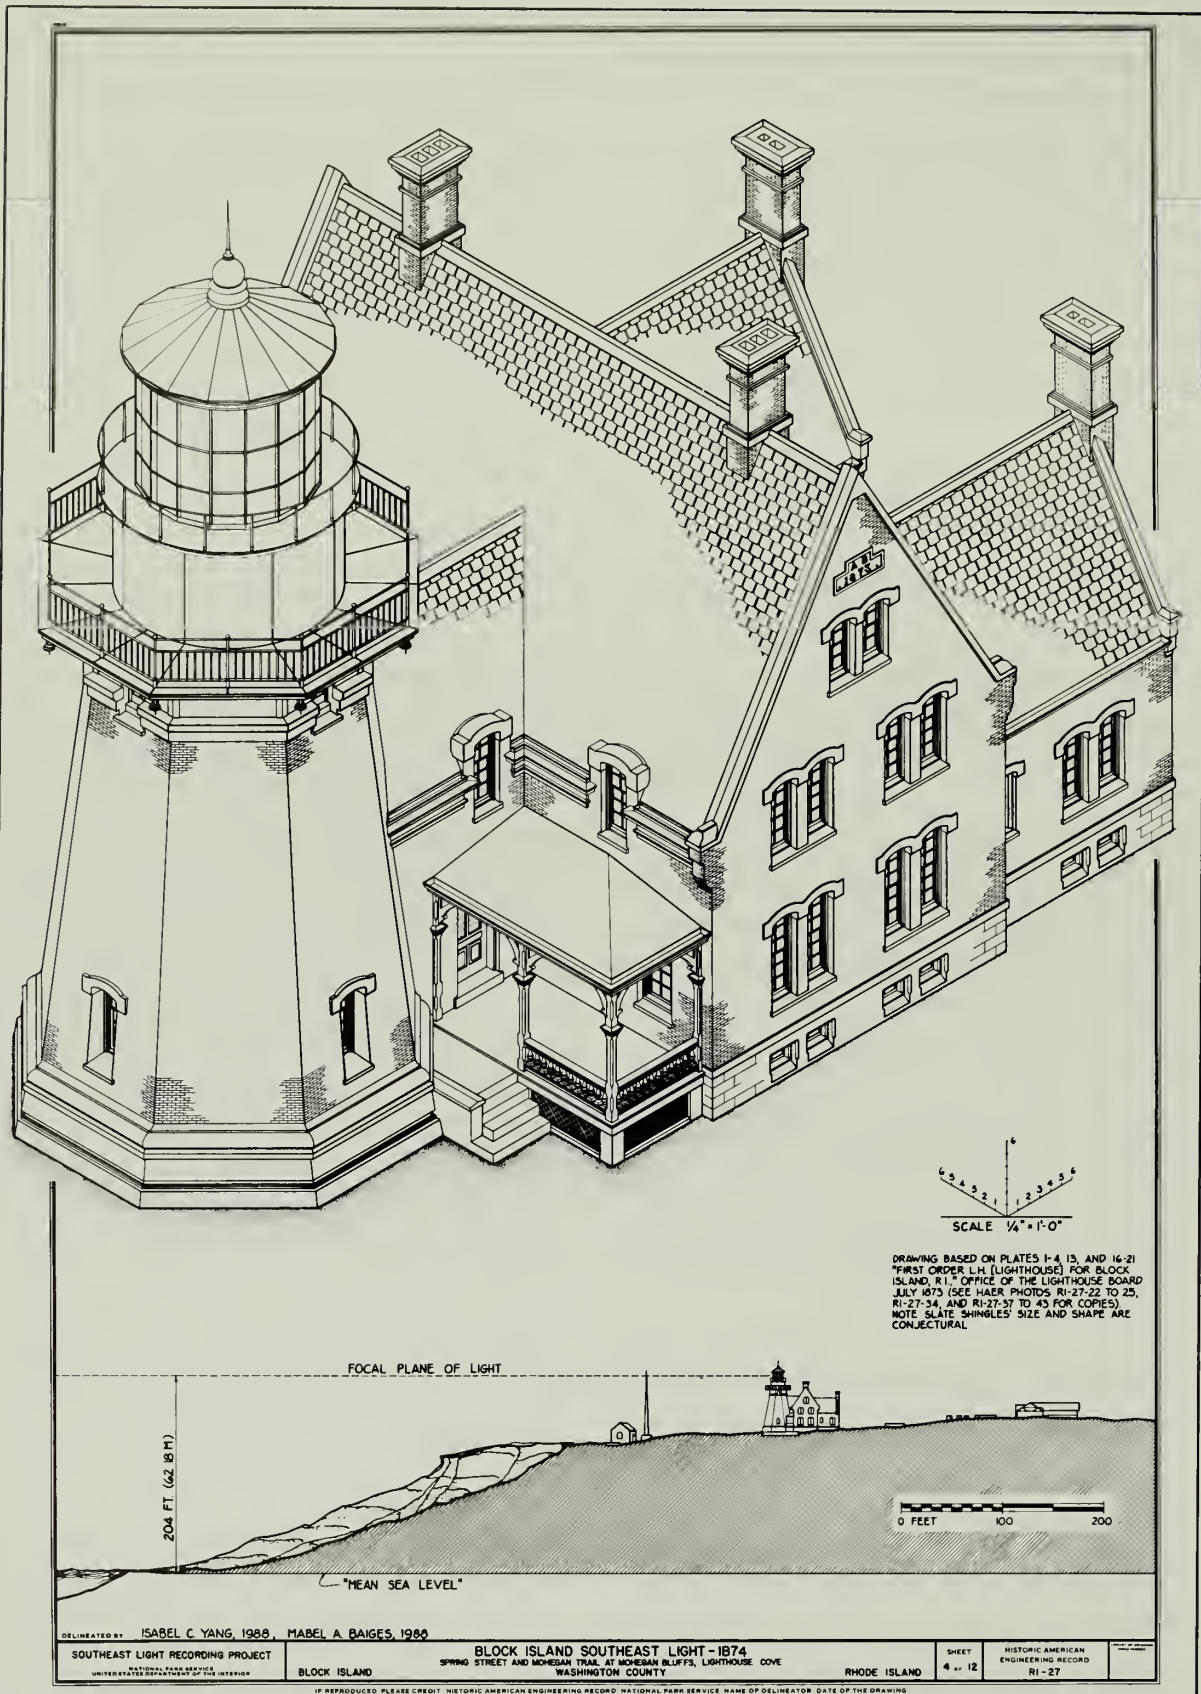
Figure 2. Isometric drawing from HAER documentation of Block Island Southeast Lighthouse, Block Island, Rhode Island (HAER RI-27).

In many cases, the first step in the preservation of a lighthouse, or any historic property, is documentation. The existing site should be recorded with drawings, photographs and historical and descriptive reports to define the characteristics and significance of that site. The HABS/HAER program of the National Park Service was created in 1933 to develop this type of documentation, establishing a standardized collection of the American-built environment, held for perpetuity within the Prints and Photographs Division of the Library of Congress. All materials are produced to archival standards and specific formats that assure a consistent

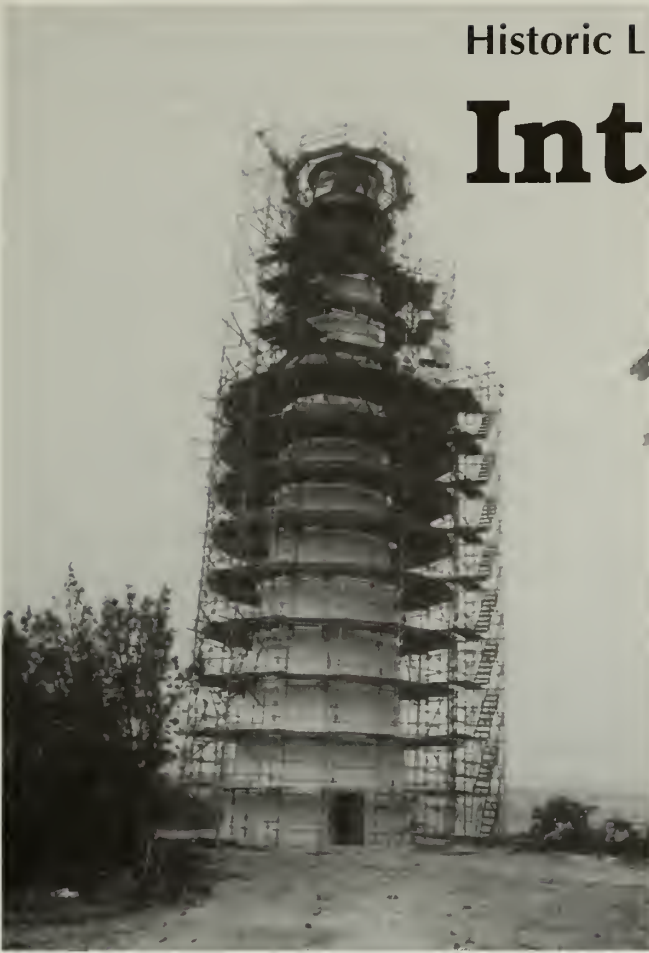
Figure 1. Brick replacement in 1996 restoration at Cape Florida Lighthouse on Key Biscayne, Florida.

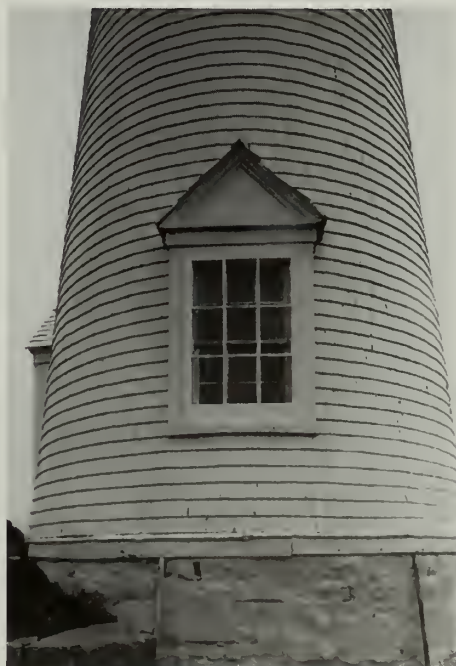
Figure 2. Stone masonry foundation in a 38-foot-tall wood-frame lighthouse in Maine.

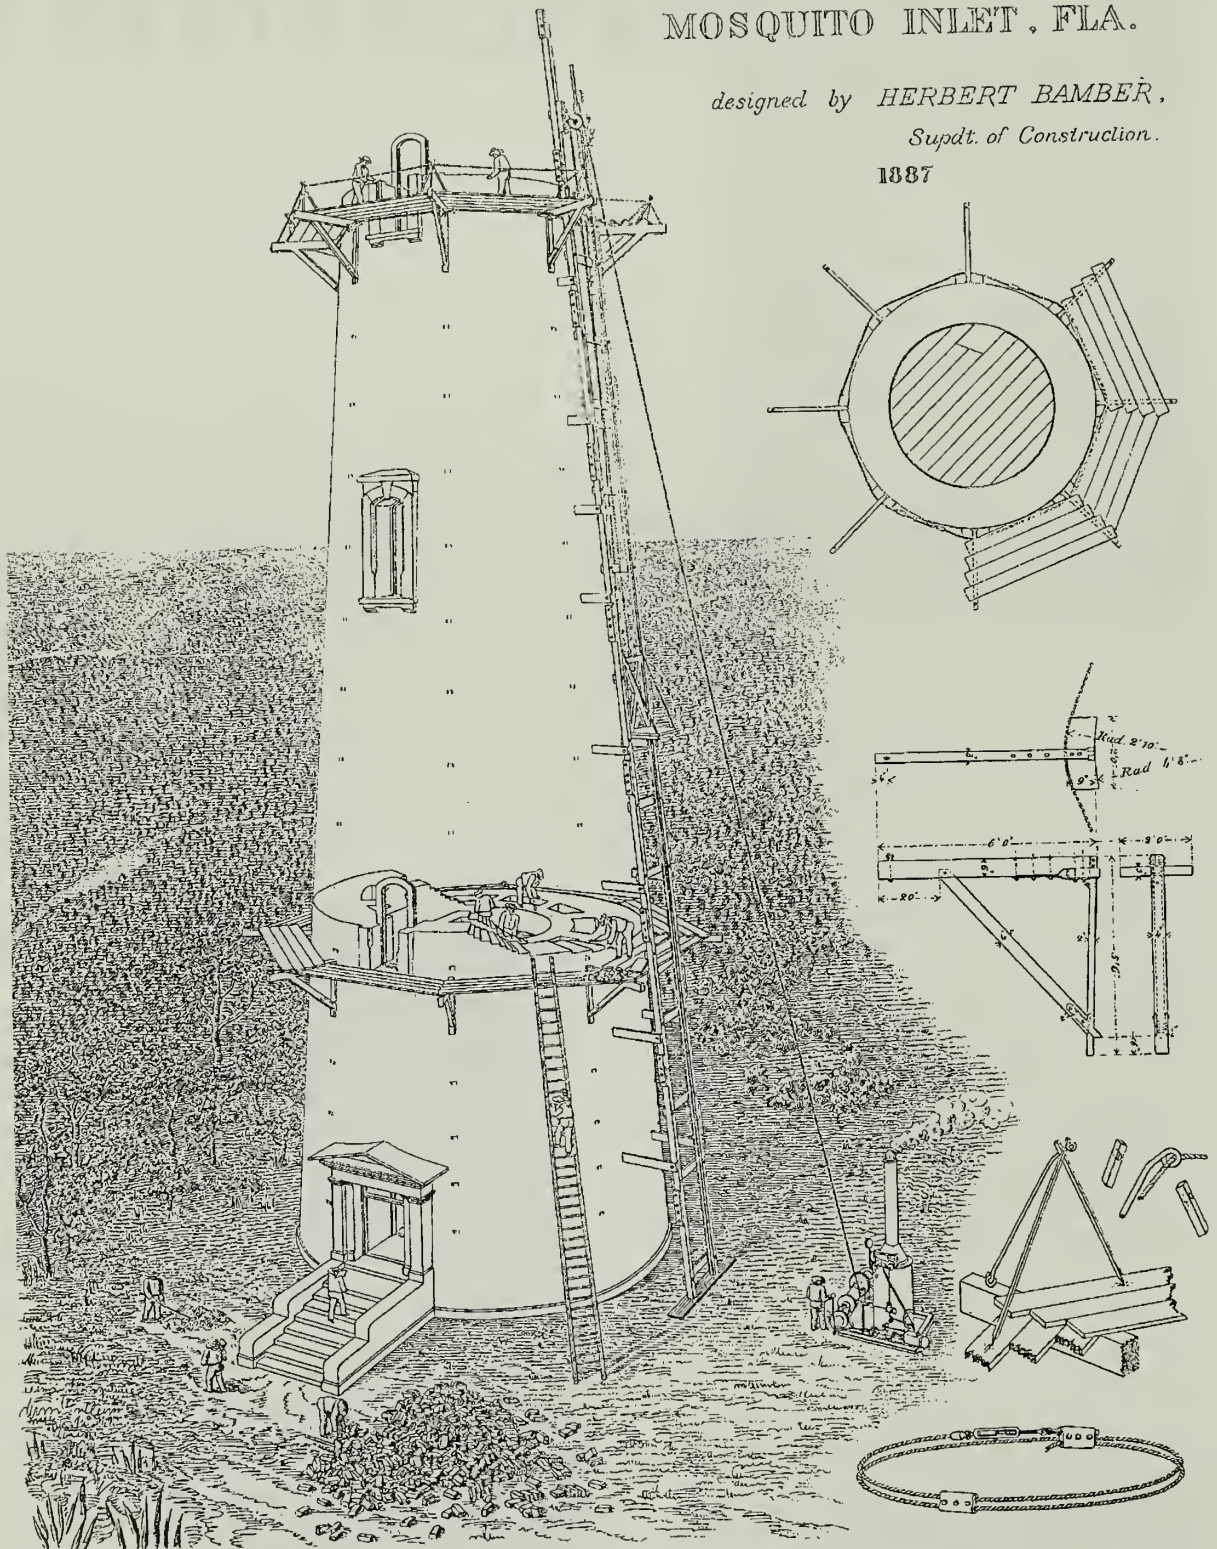
Figure 3. This construction drawing for Mosquito Inlet Lighthouse, Florida, shows the voids or cavities in the walls of tall masonry towers.

Masonry lighthouses are typically constructed in one of two configurations: solid wall or hollow cavity wall. Shorter towers tend to be solid-wall construction because the cross section of wall can be thin enough to support the lantern and interior stairs as well as economical to build. Tall towers are typically constructed with radiating cavities or voids. The exterior of the tower is the frustum of a cone while the interior is typically a cylinder. From the cylinder are radiating walls that tie into the exterior walls and create voids or cavities. The voids in the wall structure save weight while at the same time do not compromise the strength of the wall. The voids are typically vented to encourage air movement through the internal cavities. This ventilation system should be preserved and maintained.

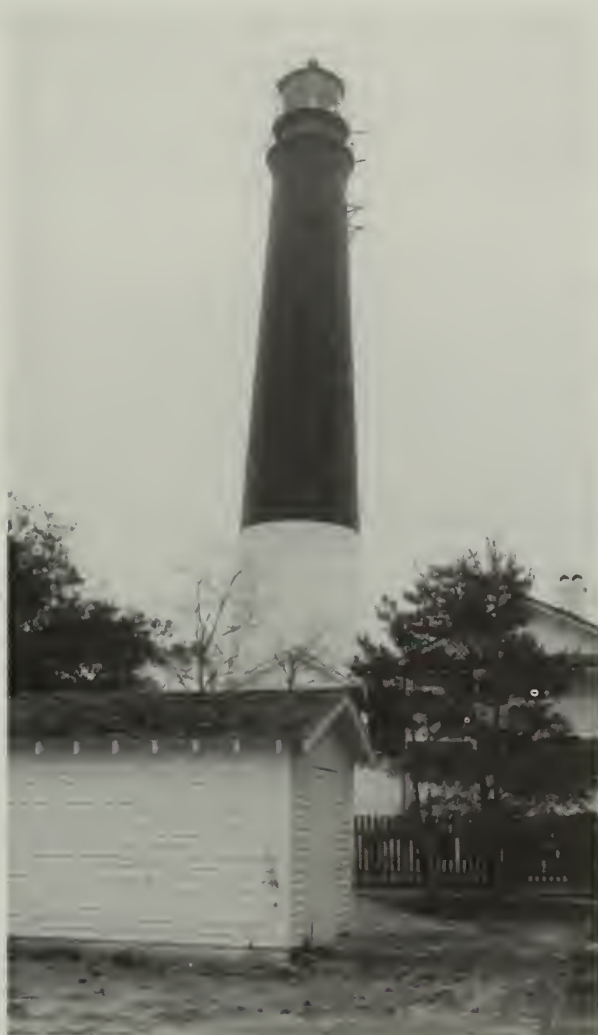
Figure 4. Brick masonry construction in the 171-foot-tall Pensacola Lighthouse in Florida.

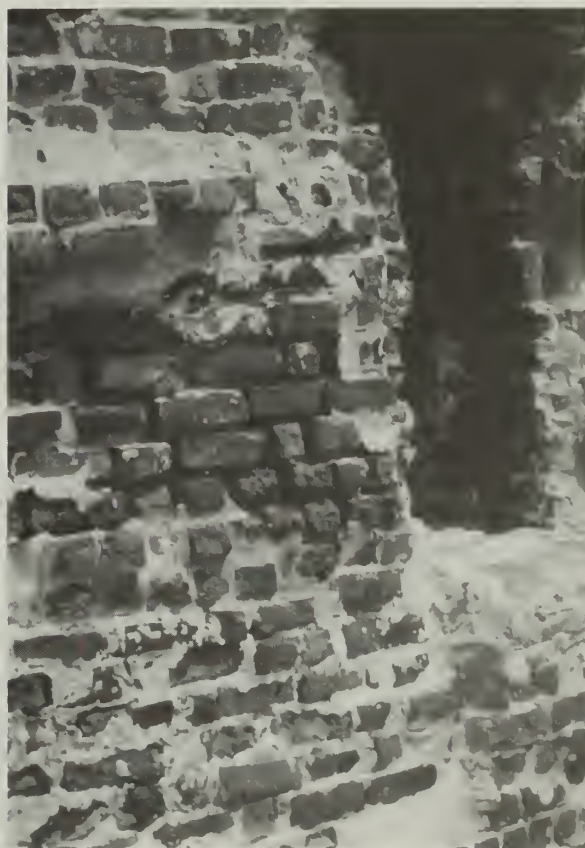
Figure 5. The coating that once protected the soft bricks of this lighthouse was not maintained; the severe deterioration required the replacement of nearly 25,000 bricks.

In some instances the vulnerable, softer masonry surfaces were not covered with a protective coating, or the protective coating was not maintained and the masonry has since deteriorated. In these cases the protective coating needs to be reinstalled after the required repairs are made, or the masonry may need to be consolidated by a qualified architectural conservator.

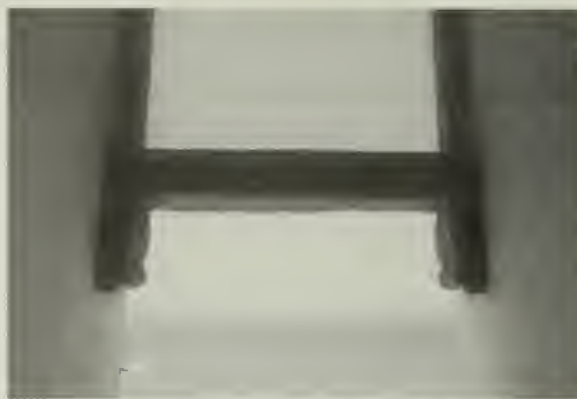
Figure 6. The once crisp edges of this decorative granite lintel have been eroded by constant high winds and airborne sand.

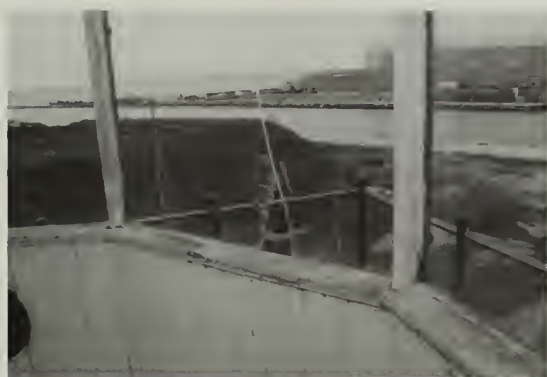
Figure 7. Lantern glass with holes and/or cracks should be replaced as soon as possible to minimize water infiltration. If immediate replacement is not feasible, the glass can be temporarily patched.

- **Lantern glass:** Lantern glass, frames, and roofs must be weathertight before mothballing. Refer to the **Lantern** section of this handbook for more information concerning weatherproofing lantern components.

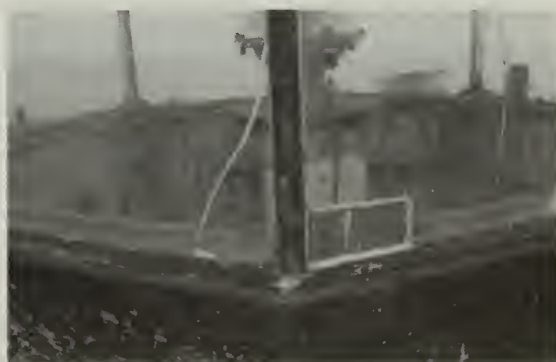
Figure 8. Detail of an acceptable temporary repair to a lantern glass using a piece of painted sheet metal that has been adhered to the glass with a high quality, exterior grade caulk. This type of temporary repair will prevent water from entering the lantern and therefore help avoid further damage. This fix should be considered only as an interim treatment until replacement of the lantern glass.

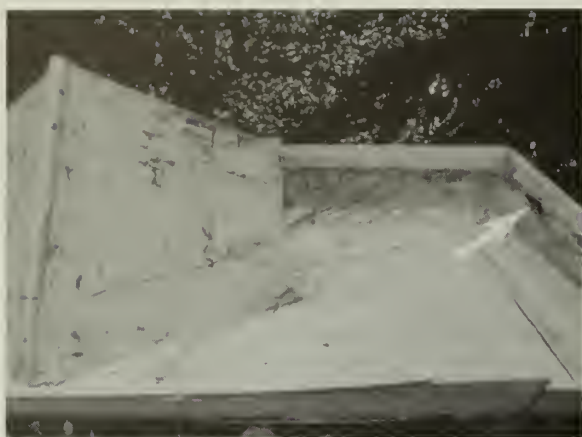
Figure 9. View of built-in gutter system on a mansard-style roof; the arrow indicates where a fist-size hole exists. This hole allows water to enter the interior of the lighthouse.

- **Built-in gutter systems:** All rainwater gutter systems (lantern roofs, or other tower roof forms) should be cleaned and checked for holes. All holes and non-functioning gutter system components should be repaired. For more information refer to the discussion on roofing in the **Lantern** section of the handbook.

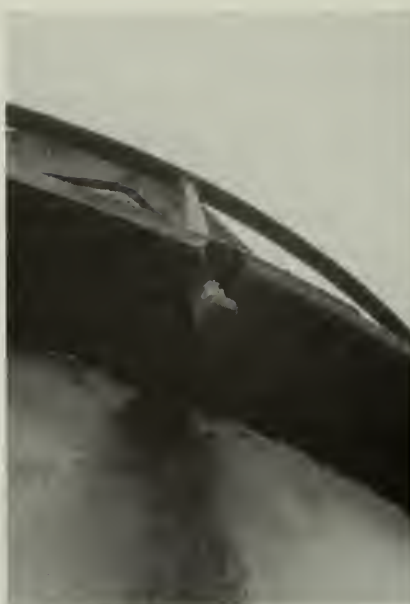
Figure 10. View of underside of gallery deck; the streaks on the stucco indicate that water is passing between the deck plates and possibly entering the masonry wall.

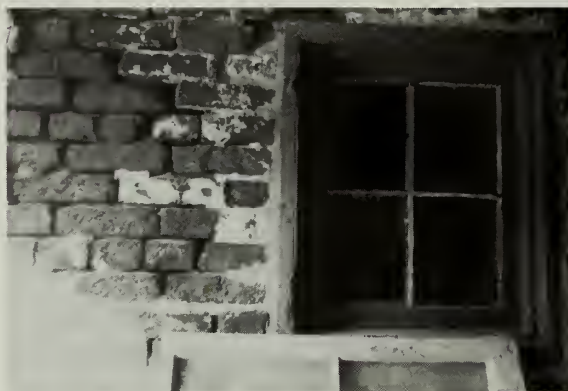
Figure 11. Detail of severely eroded brick and painting.

- **Loose or eroded mortar joints:** If pointing between masonry units is loose, cracked, eroded, or is completely missing, moisture will penetrate (see Figure 11). In order to prevent this infiltration, all pointing that is in disrepair must be removed and the affected joints repointed. For more information refer to the discussion on repointing under the **Repair** treatment in this section of the handbook.

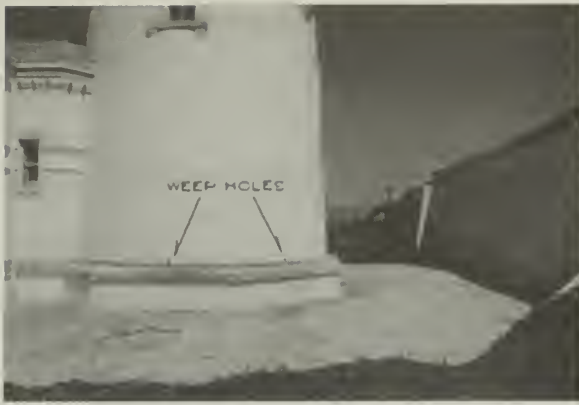
Figure 12. Typical masonry lighthouse weep hole locations. Each weep hole provides drainage for each individual cavity within the masonry wall.

- **Weep and vent holes:** If the walls have cavities between the interior and exterior walls, weep holes may exist at or near the base of these walls. Weep holes typically range in size from small slits to large brick headers. These holes allow any moisture that has entered the cavity between the walls to drain out. These openings must be kept clear in order to provide sufficient drainage of the cavity. In some instances the walls may have vent holes (larger than weep holes) that allow the movement of air through the cavities or voids. Typically vent holes open into the interior. These openings must be kept clear in order to provide sufficient ventilation (see Figure 12).
- **Protective coatings:** Lighthouses were often painted as a protective measure and for identification as a daymark. As part of a

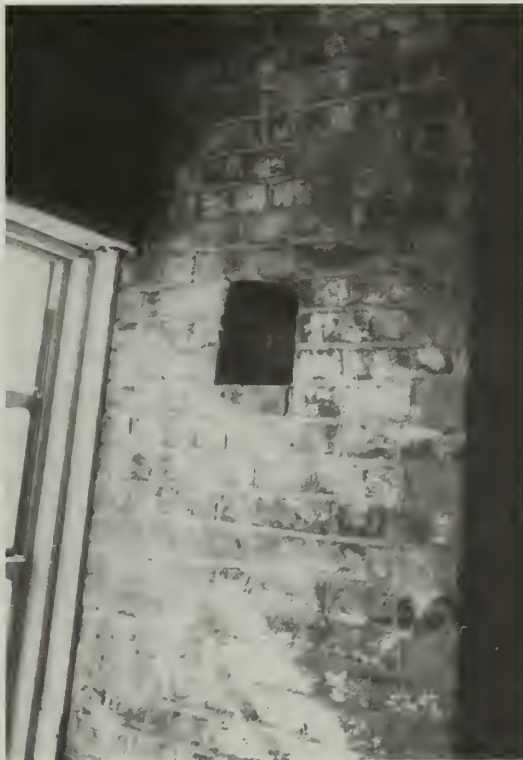
Figure 13. Vent hole located in the window well of a brick lighthouse.

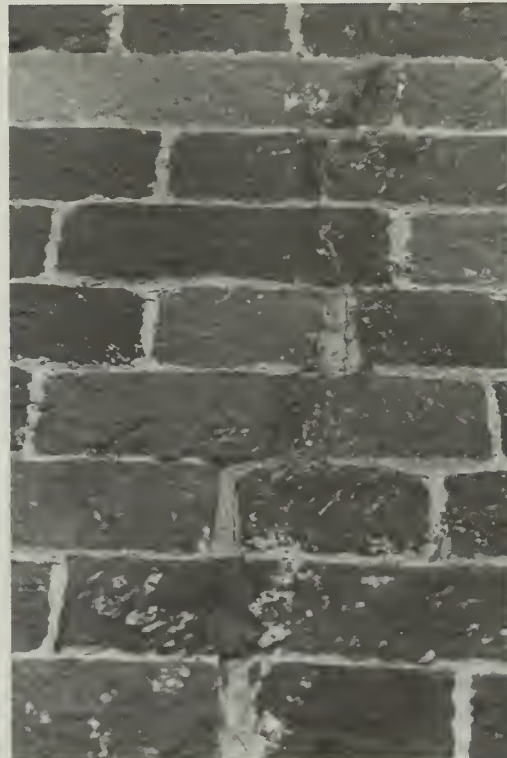
Figure 15. Cracks such these in a sandstone lighthouse should be monitored for movement prior to treatment.

- **Open cracks in walls:** Cracks in exterior masonry walls indicate that movement has occurred, either caused by shrinkage (in the case of stucco) or by settlement or mechanical impact. Cracks should be monitored to determine if movement is still occurring and

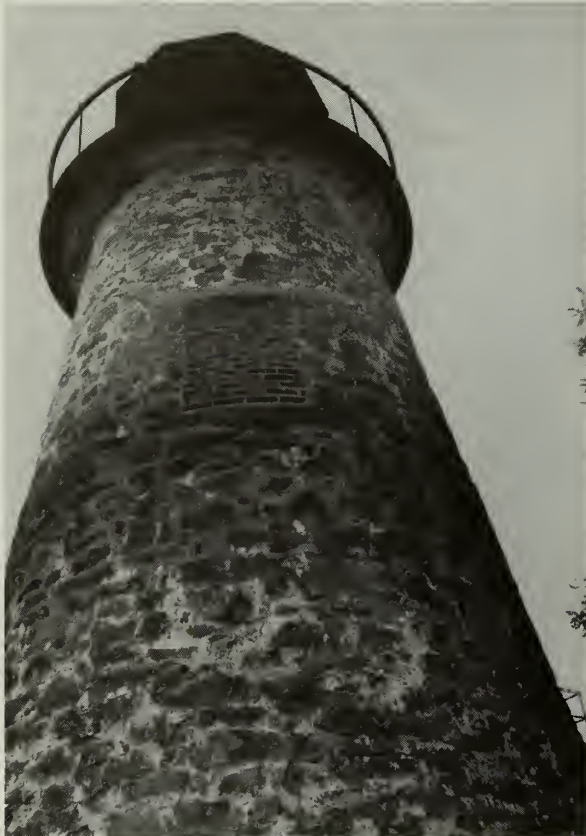
Figure 16. An example of a reversible masonry stabilization treatment for the window opening that has prevented structural deterioration and moisture infiltration.

‘mothballed’ period. If funds are insufficient to make structural repairs, structural stabilization should be performed as a less expensive temporary alternative. Temporary blocking in of window and door openings and installation of interior or exterior shoring or bracing are all stabilization methods. Figure 16 illustrates a window opening that has been stabilized with brick infill. Brick is a historic stabilization method in stone masonry construction. If this method is used, the

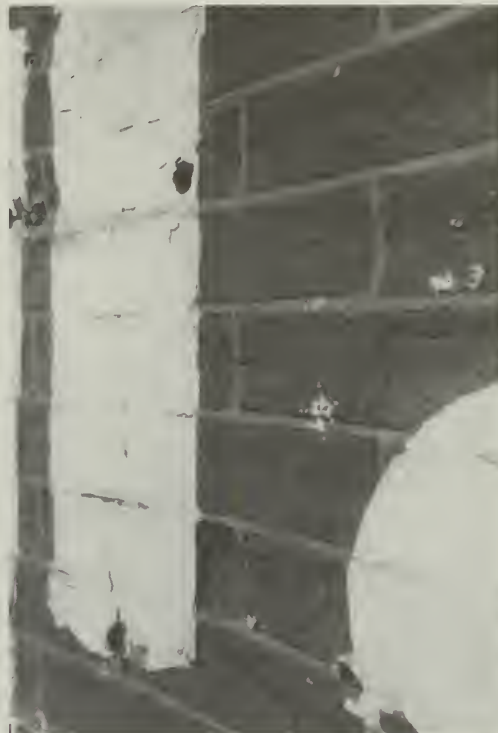
Figure 17. Deeply eroded brick as a result of sandblasting. The white areas are where electrical components were attached to the wall at the time of sandblasting.

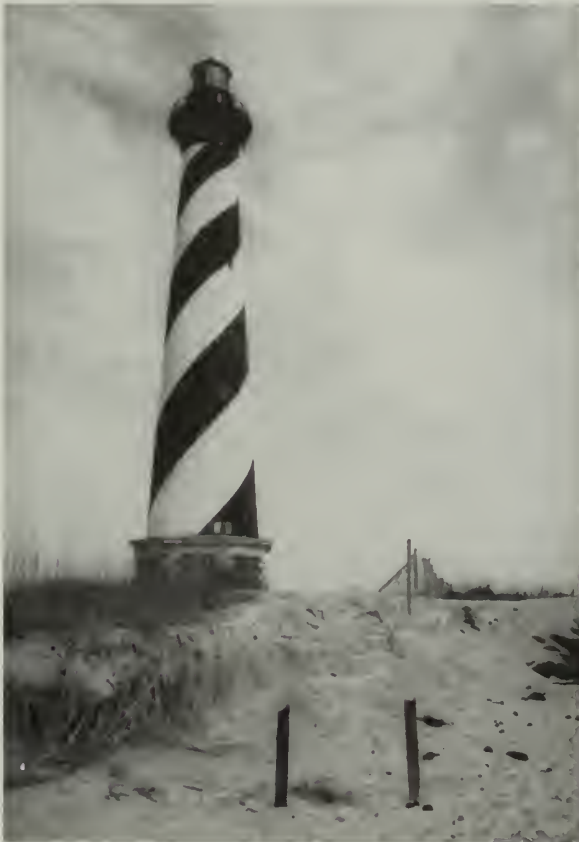
Figure 16. Daymark patterns are a character-defining feature and should be preserved.

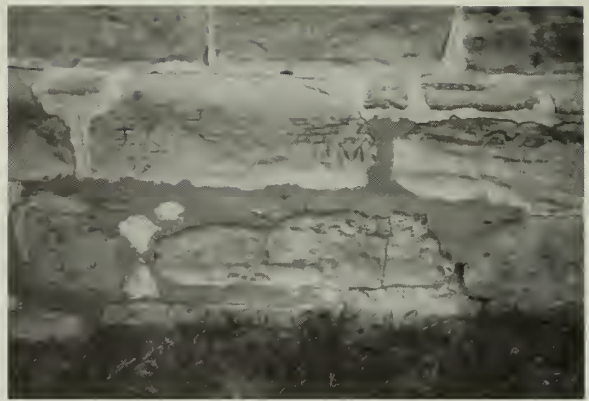
Figure 19. The use of hard portland cement mortar and sloppy pointing technique have aided in the deterioration of this soft sandstone wall.

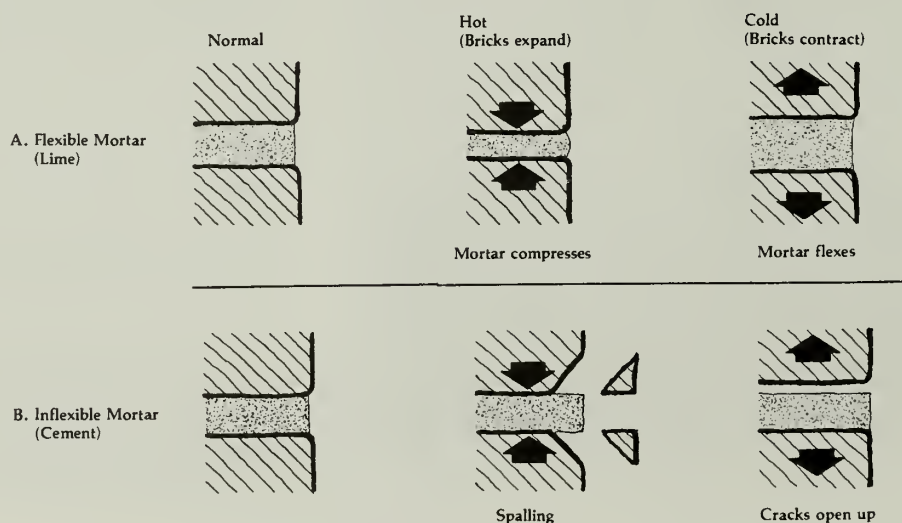
Figure 20. Diagram showing the behavior of lime-based mortar and cement-based mortar during relative temperature changes of the surrounding masonry. (Source: NPS *Preservation Briefs 2*, 1980)

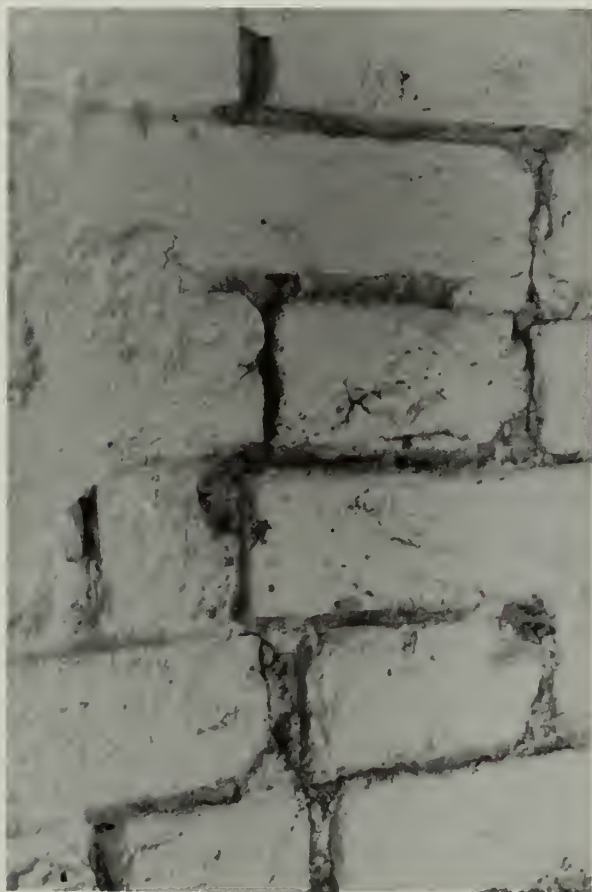
Figure 21. Detail of eroded pointing.

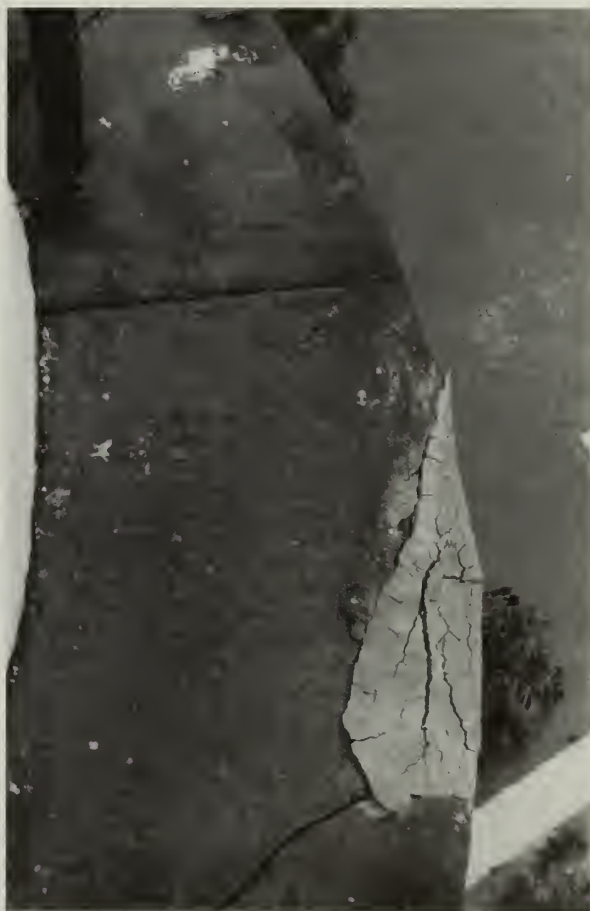
Figure 22. A failing repair made to a stone gallery deck using a simulated stone material. A stone dutchman repair should have been used.

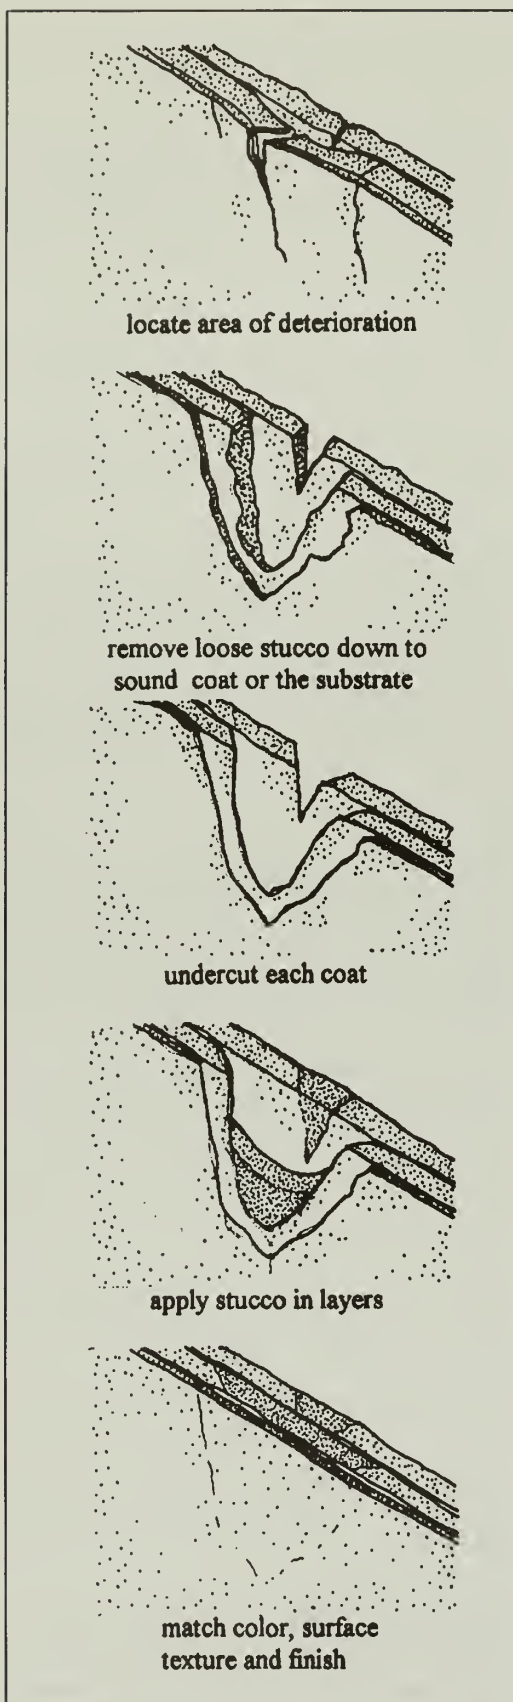
Figure 23. The five basic steps of stucco repair; each layer of stucco must be patched separately. (NPS drawing)

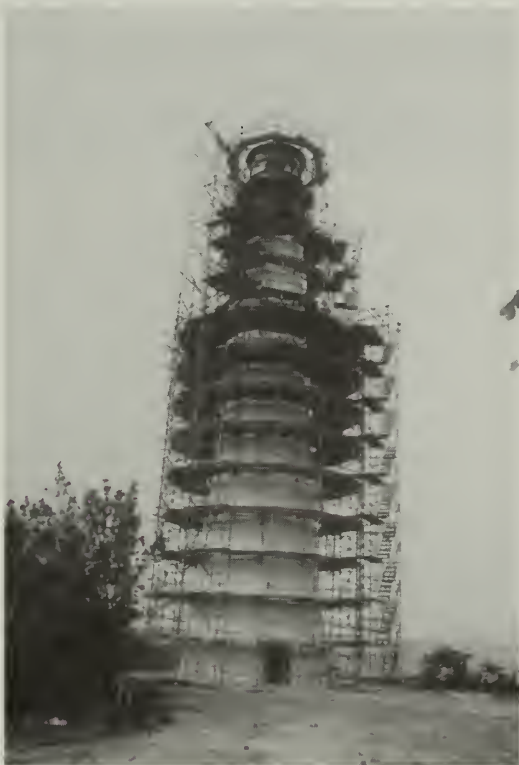
Figure 24. Cape Florida Lighthouse with scaffolding used during the 1996 restoration. The white coating on the tower is the lime mortar wash applied to help protect the damaged brick and to restore the tower to its 1846 appearance.
